# PRESERVING THE PAST

## A Precedent In Improving Historic Windows

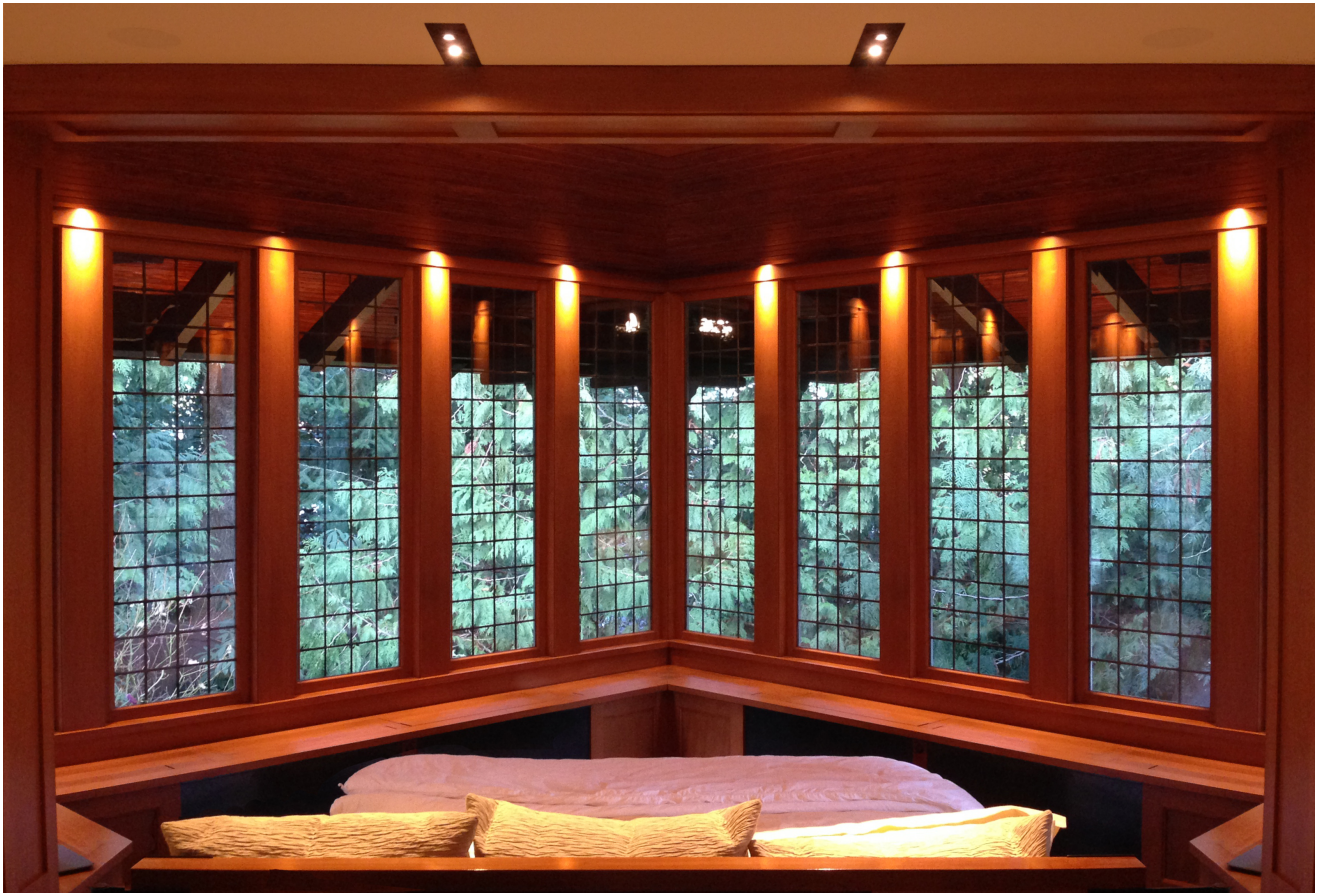
Interior view of historic window restoration in Master bedroom.

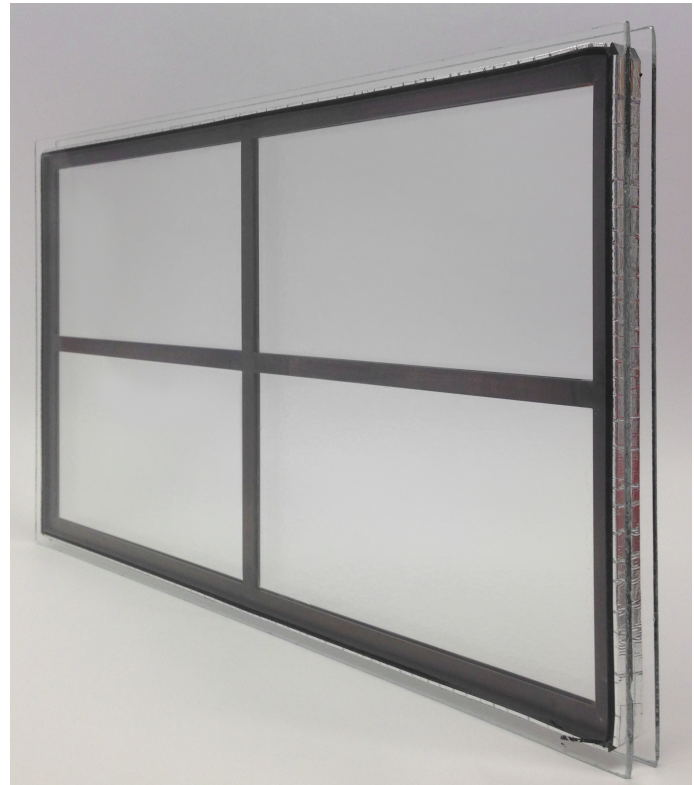
A sample of the leaded glass inserted as the center pane of a triple pane assembly

Working with a local glass company, we designed an insulated glass unit that holds the historic leaded pane between two new panes. The glass company carefully disassembled the original windows, numbering and tracking each important piece. After repairs and cleaning, the original lead and glass was reassembled and inserted as the center pane of a new insulated triple pane glass unit.

The exterior panes on either side of the leaded original pane are 1/8" thick low iron glass. It is the Iron content in glass that is responsible for the green tint and reduced clarity in typical glass. Low iron glass has no visible green tint, and is incredibly clear. We chose low iron for the exterior panes so these additional panes disappear, highlighting only the original glass in the window.

A spacer separates each pane by 1/8" to eliminate thermal bridging, rattling and rubbing. This spacer made of desiccated foam and a foil facing deflects water vapor and gas. The entire unit was then fitted with an additional layer of foil facing to prevent moisture and dirt from entering between panes.
